| <b>Prüfbericht-Nr.:</b><br><i>Test report no.:</i> | <b>CN24FVND 001</b> | <b>Auftrags-Nr.:</b><br><i>Order no.:</i> | 170383396 | Seite 1 von 14<br><i>Page 1 of 14</i> |
| <b>Prüfgegenstand:</b><br><i>Test item:</i> | Balustrades mounting system | | | |
| <b>Bezeichnung / Typ-Nr.:</b><br><i>Identification / Type no.:</i> | SR-HCFA-A<br>SR-HCAA-A<br>SR-HFFA-A(SR-HBFA-A)<br>SR-HFAA-A(SR-HBAA-A)<br>SR-HTFA-B | | | |
| <b>Auftrags-Inhalt:</b><br><i>Order content:</i> | Wind load resistance performance test for Balustrades mounting system | | | |

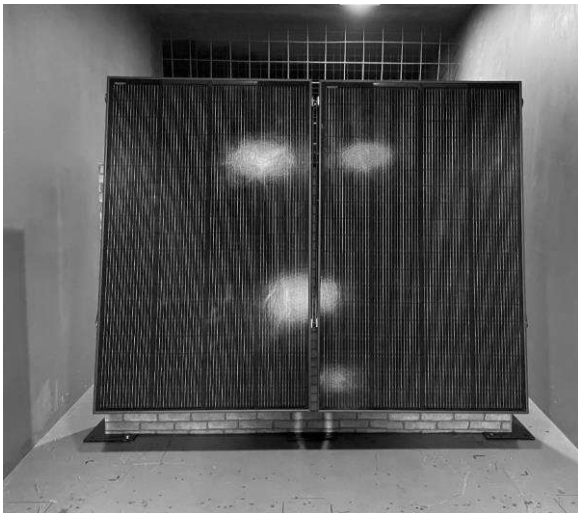
| Absatz<br>Clause | Anforderungen - Prüfungen /<br>Requirements - Tests | Messergebnisse – Bemerkungen/<br>Measuring results - Remarks | Ergebnis<br>Result |
|---|---|---|---|
| 10.1.1 | PV module facing wind (0°) | | |

<table><tr><th>Wind direction</th><th>PV module tile angle</th><th>Wind velocity</th><th>Duration</th><th>Phenomenon</th></tr><tr><td>35 m/s</td><td>5 min</td><td>There was no visual damage detected on PV module, mounting system connection and components.</td></tr><tr><td>45 m/s</td><td>5 min</td><td>There was no visual damage detected on PV module, mounting system connection and components.</td></tr><tr><td>55 m/s</td><td>5 min</td><td>There was no visual damage detected on PV module, mounting system connection and components.</td></tr><tr><td>Turn off the blower</td><td>/</td><td>There was no visual deformation, loosening or destruction of components detected on test sample after testing.</td></tr></table>

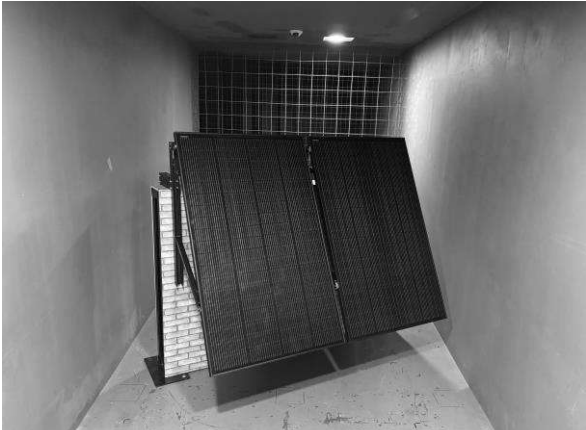
| Absatz<br>Clause | Anforderungen - Prüfungen /<br>Requirements - Tests | Messergebnisse – Bemerkungen/<br>Measuring results - Remarks | Ergebnis<br>Result |
|---|---|---|---|
| 10.1.2 | PV module side facing wind (30°) | | |

| Wind direction | PV module tile angle | Wind velocity | Duration | Phenomenon |
|---|---|---|---|---|
| | | Turn off the blower | / | There was no visual deformation, loosening or destruction of components detected on test sample after testing. |

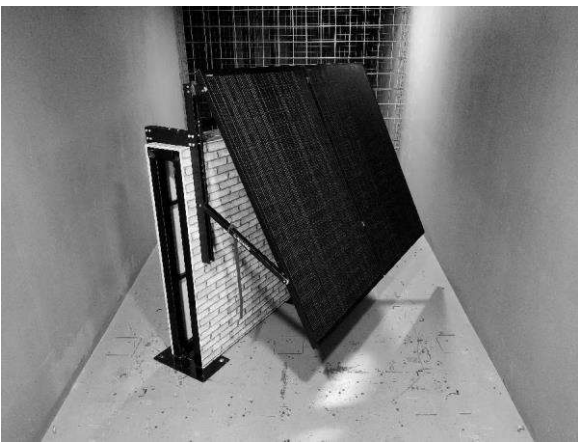
| Absatz<br>Clause | Anforderungen - Prüfungen /<br>Requirements - Tests | Messergebnisse – Bemerkungen/<br>Measuring results - Remarks | Ergebnis<br>Result |
|---|---|---|---|
| 10.1.3 | PV module side facing wind (60°) | | |

| Wind direction | PV module tile angle | Wind velocity | Duration | Phenomenon |
|---|---|---|---|---|
| | | Turn off the blower | / | There was no visual deformation, loosening or destruction of components detected on test sample after testing. |

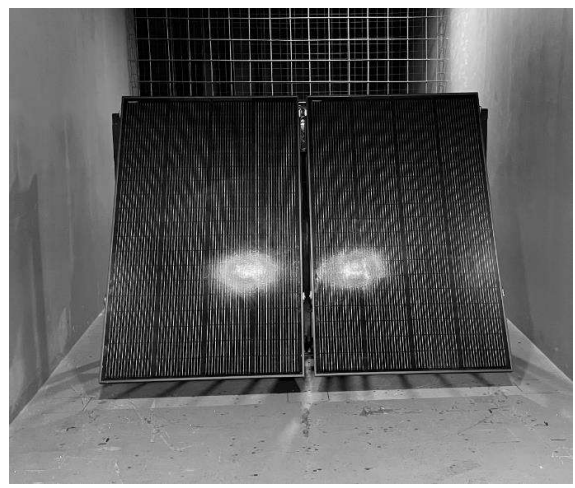
| Absatz<br>Clause | Anforderungen - Prüfungen /<br>Requirements - Tests | Messergebnisse – Bemerkungen/<br>Measuring results - Remarks | Ergebnis<br>Result |
|---|---|---|---|
| 10.2.1 | PV module facing wind (0°) | | |

| | | | Turn off the blower | / | There was no visual deformation, loosening or destruction of components detected on test sample after testing. |

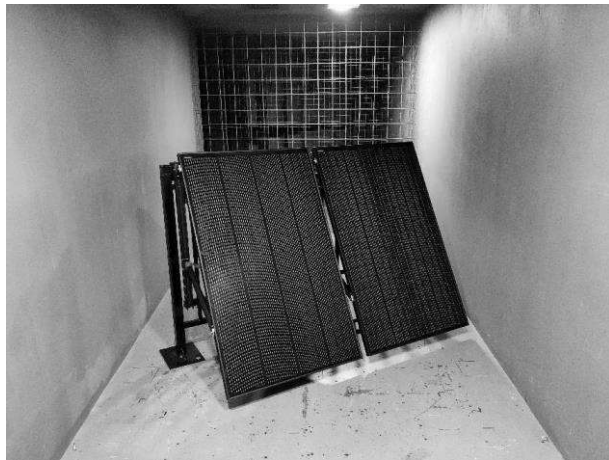
| Absatz<br>Clause | Anforderungen - Prüfungen /<br>Requirements - Tests | Messergebnisse – Bemerkungen/<br>Measuring results - Remarks | Ergebnis<br>Result |
|---|---|---|---|
| 10.2.2 | PV module side facing wind (30°) | | |

| | | | Turn off the blower | / | There was no visual deformation, loosening or destruction of components detected on test sample after testing. |

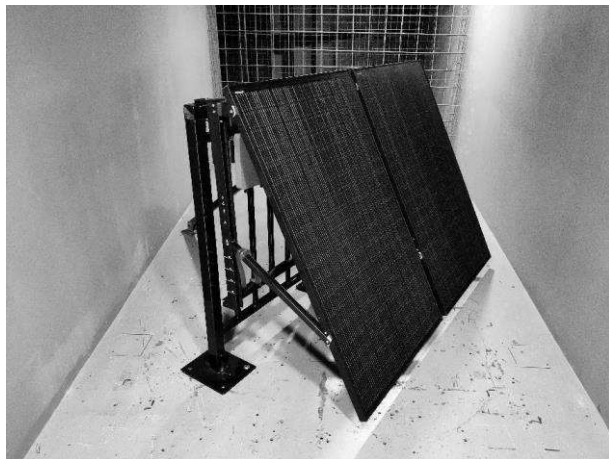
| Absatz<br>Clause | Anforderungen - Prüfungen /<br>Requirements - Tests | Messergebnisse – Bemerkungen/<br>Measuring results - Remarks | Ergebnis<br>Result |
|---|---|---|---|
| 10.2.3 | PV module side facing wind (60°) | | |

| Wind direction | PV module tile angle | Wind velocity | Duration | Phenomenon |
|---|---|---|---|---|
| | | Turn off the blower | / | There was no visual deformation, loosening or destruction of components detected on test sample after testing. |

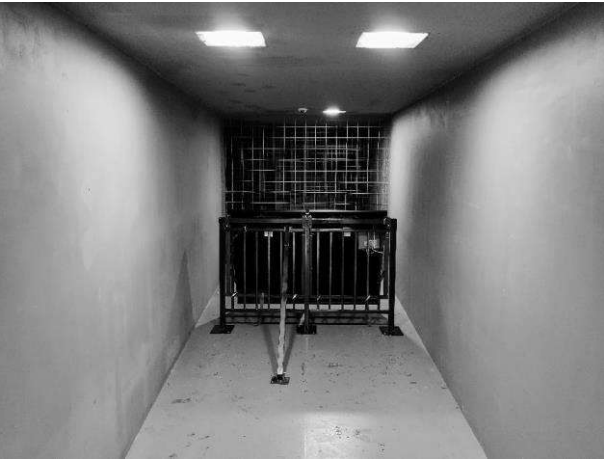
| Absatz<br>Clause | Anforderungen - Prüfungen /<br>Requirements - Tests | Messergebnisse – Bemerkungen/<br>Measuring results - Remarks | Ergebnis<br>Result |
|---|---|---|---|
| 10.2.4 | <p>PV module backside facing wind (180°)</p> <p>Before test</p> | <p>After test</p> | |

| Wind direction | PV module tile angle | Wind velocity | Duration | Phenomenon |
|---|---|---|---|---|
| | | Turn off the blower | / | There was no visual deformation, loosening or destruction of components detected on test sample after testing. |

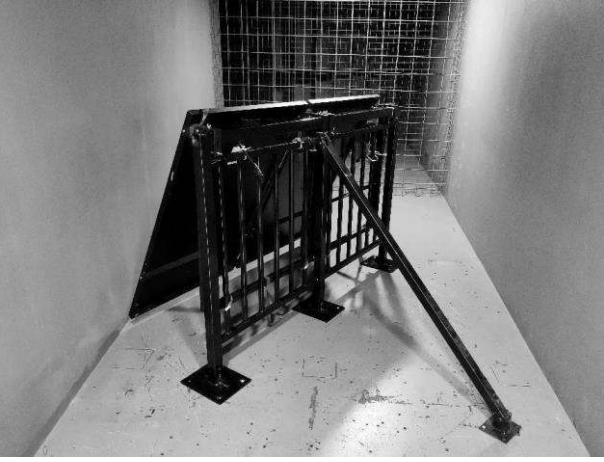
| Absatz<br>Clause | Anforderungen - Prüfungen /<br>Requirements - Tests | Messergebnisse – Bemerkungen/<br>Measuring results - Remarks | Ergebnis<br>Result |
|---|---|---|---|
| 10.2.5 | <p>PV module backside facing wind (210°)</p> <p>Before test</p> | <p>After test</p> | |

| Wind direction | PV module tile angle | Wind velocity | Duration | Phenomenon |
|---|---|---|---|---|
| | | Turn off the blower | / | There was no visual deformation, loosening or destruction of components detected on test sample after testing. |

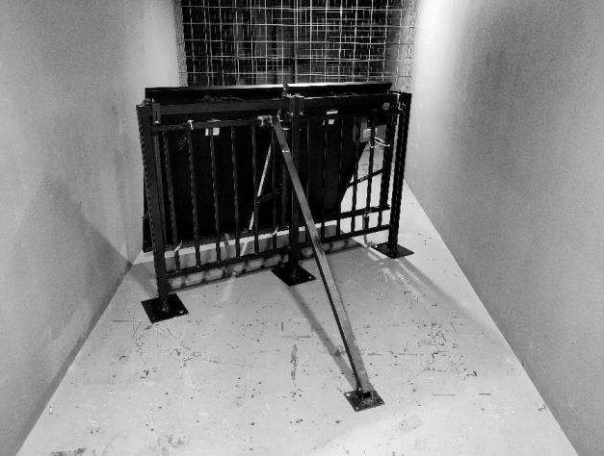
| Absatz<br>Clause | Anforderungen - Prüfungen /<br>Requirements - Tests | Messergebnisse – Bemerkungen/<br>Measuring results - Remarks | Ergebnis<br>Result |
|---|---|---|---|
| 10.2.6 | <p>PV module backside facing wind (240°)</p> <p>Before test</p> | <p>After test</p> | |

| Wind direction | PV module tile angle | Wind velocity | Duration | Phenomenon |
|---|---|---|---|---|
| | | Turn off the blower | / | There was no visual deformation, loosening or destruction of components detected on test sample after testing. |
